Turf Sweeper 4800

44044 70101-80300

Subject: Reel Drive Belt Jumps Off Pulley.

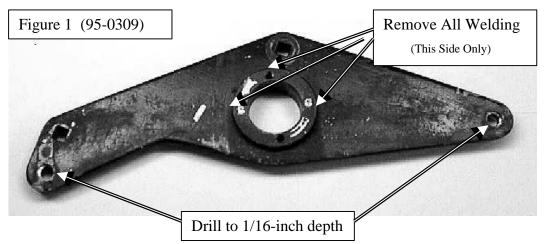
Some of the units within the serial number range listed above can experience repeat occurrences of the reel drive belt jumping off the pulley. The Adjustment Arm that holds the pulley being incorrectly manufactured can cause this belt jumping. The Adjustment Arm can have either of two conditions as follows:

- There could be welds on the inboard side of the Adjustment Arm.
- ◆ There is no chamfer for the carriage bolts that retain the arm.

Affected units should have the welds removed and the retaining bolt holes chamfered. Should you feel this condition exists on your unit contact your local Authorized TORO Distributor for assistance in resolving this issue.

- 1. Stop the engine. Set the Parking Brake and remove the key.
- 2. Remove belts as described in the Operator's Manual.
- 3. Remove the Adjustment Arm assembly.(The idler arm and pulley assembly will be attached to the Adjustment Arm)
- 4. Lay the assembly on the bench, pulleys down, and remove the Idler arm.
- 5. Remove welds with a suitable tool and using a ½ in. drill chamfer the retaining bolt holes to a depth of 1/16-in. **Do not drill all the way through the adjustment arm.**
- 6. Paint any exposed metal surface.
- 7. Reinstall the idler arm and then the Adjustment Arm assembly.
- 8. Reinstall the belts and adjust as described in the Operator's Manual.
