**Huawei WLAN • Wi-Fi Experience
Interoperability Test Reports**

**Test Report on Terminal Compatibility of Huawei's
WLAN Products**

Huawei Technologies Co., Ltd.

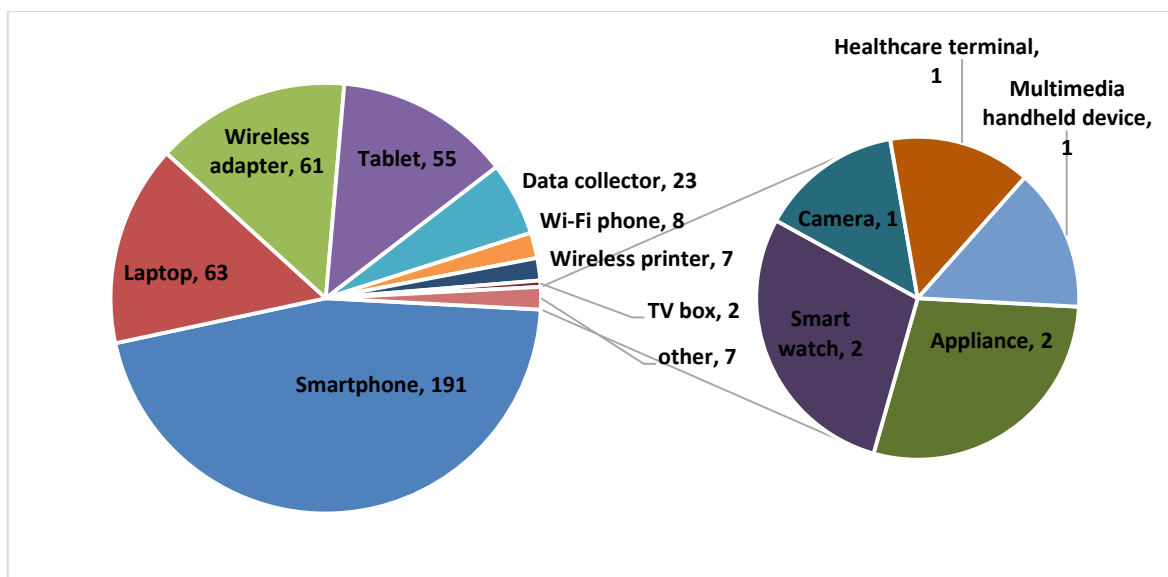
Until now, a total of 417 terminals are selected for the test, including 191 mobile phones, 63 laptops, 55 tablets, 61 wireless adapters, 23 data collectors, 8 Wi-Fi phones, 7 wireless printers, 2 TV boxes, 2 appliances, 2 smart watches, 1 multimedia portable entertainment device, 1 camera, and 1 healthcare terminal.

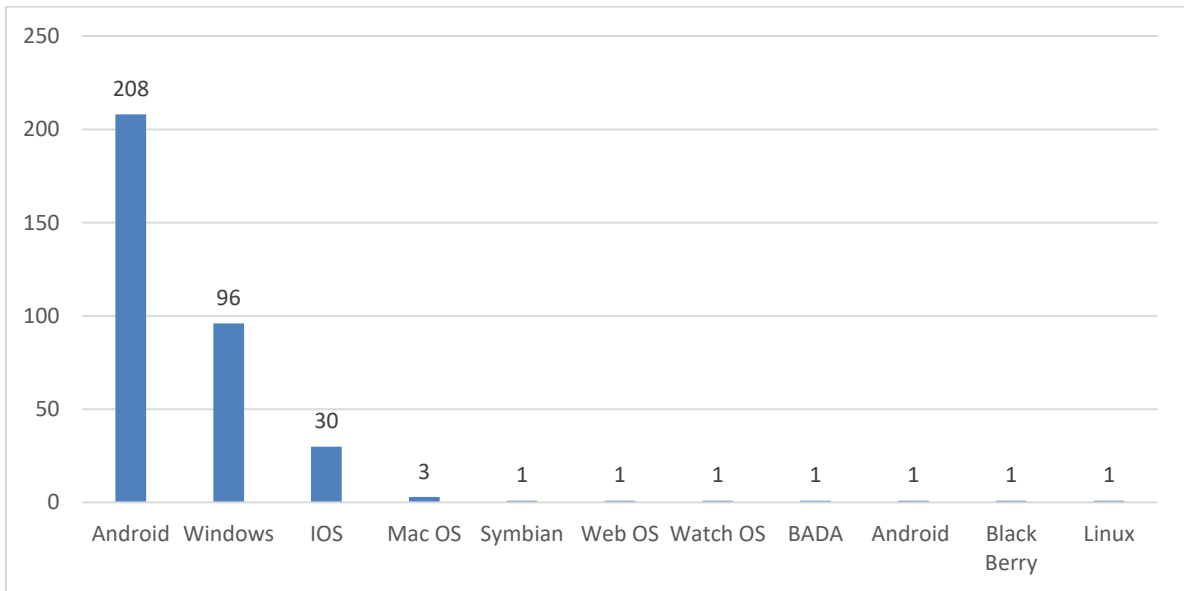
Operating systems of these terminals cover the mainstream mobile and desktop operating systems, including iOS, Android, and Windows, and other operating systems such as BlackBerry.
